## **Accessibility Analysis of Public Locations Near Akademia WSB**

*Accessibility Evaluation of Urban Infrastructure for People with Disabilities.*

**Author: Gisselle Juliana Botina Márquez**  
**Institution: Akademia WSB**  
**Project: Accessibility Field Evaluation**  
**Location: Dąbrowa Górnicza, Poland**  
**Date: 17/03/2026**

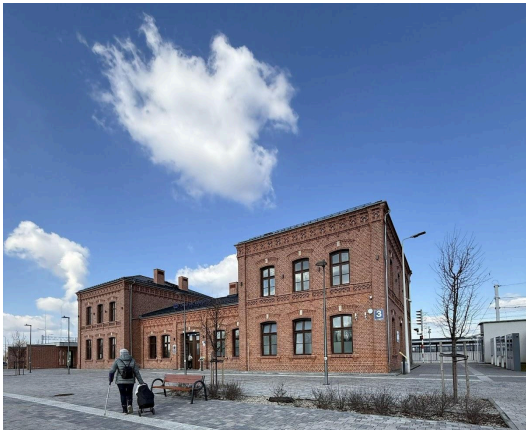
### 4.2.1 PKP Railway Station

Category	Key Criteria	Result
Physical Accessibility	Elevator access	Yes
Physical Accessibility	Accessible toilet	Partial
Mobility & Surface	Circulation space	Partial
Mobility & Surface	Accessible parking	Yes
Visual Accessibility	Braille signage	Partial
Visual Accessibility	Tactile guidance	Yes
Hearing Accessibility	Audio announcements	Yes
Hearing Accessibility	Hearing loop	Yes

- Elevators connecting platforms
- Audio announcements for passengers

- Limited tactile guidance for visually impaired users
- Lack of signage at all exits

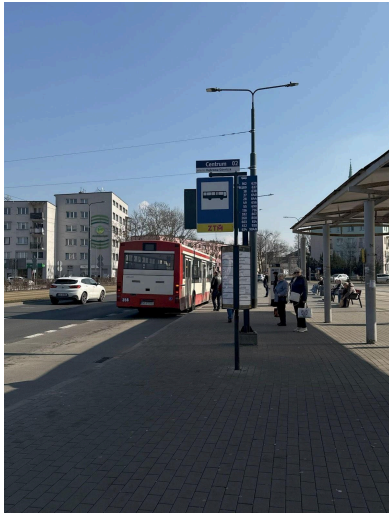
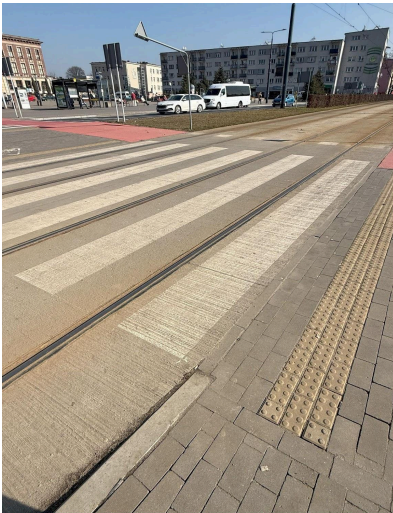
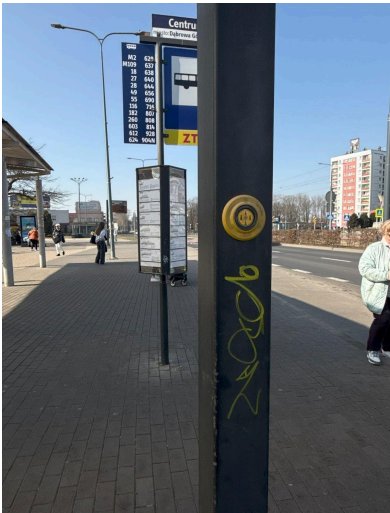
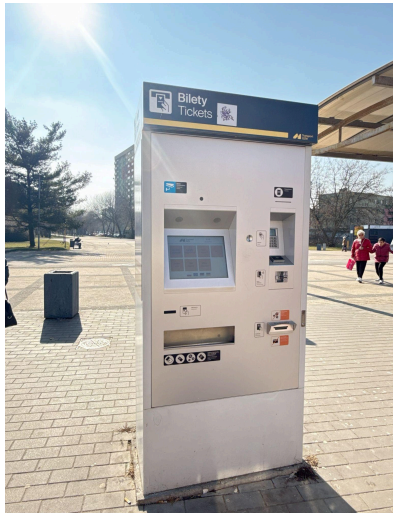
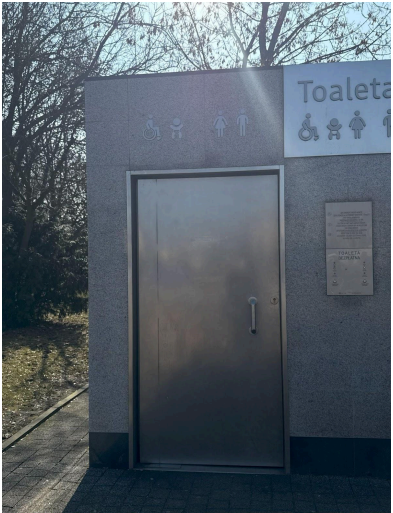
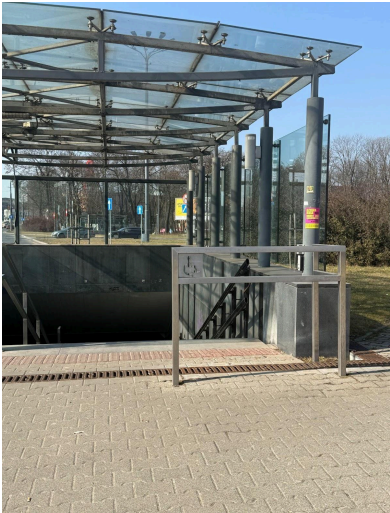
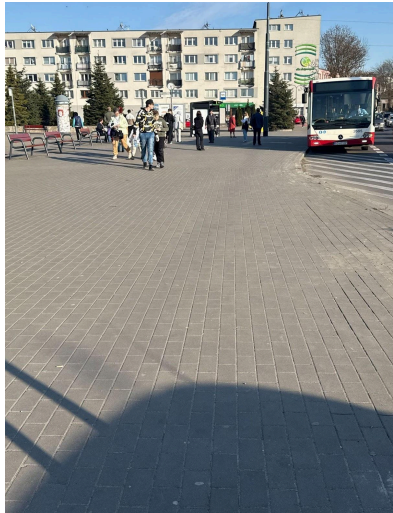
#### 4.2.2 Main Bus Stop (PKZ)

Category	Key Criteria	Result
Physical Accessibility	Step-free boarding area	Yes
Mobility & Surface	Pedestrian access	Yes
Visual Accessibility	Information signage	Yes
Visual Accessibility	Tactile guidance	Partial

- Accessible bus boarding area
- Clear passenger information systems
- Smooth pedestrian circulation

- Limited tactile pavement guidance

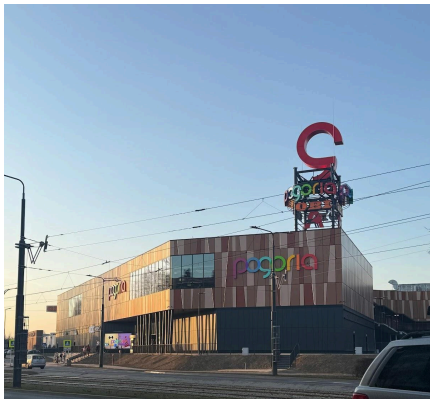
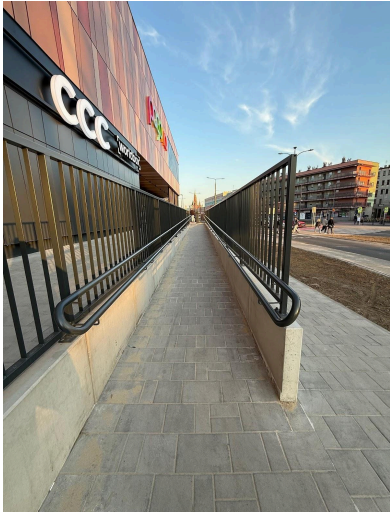
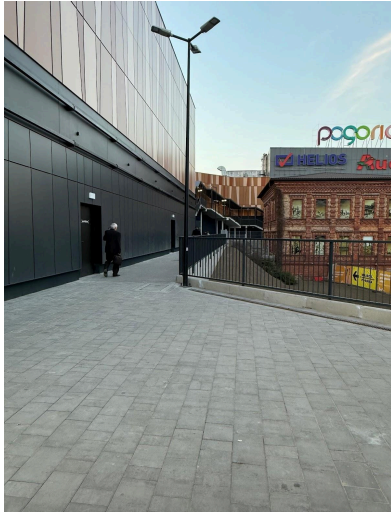
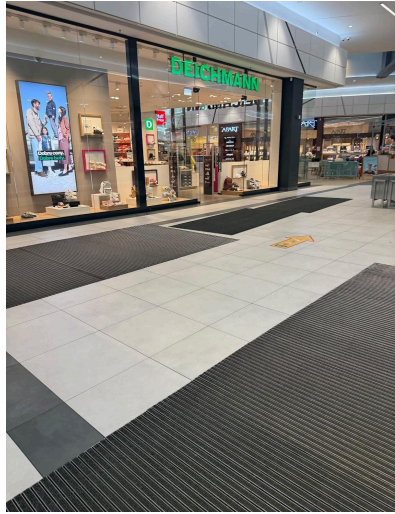
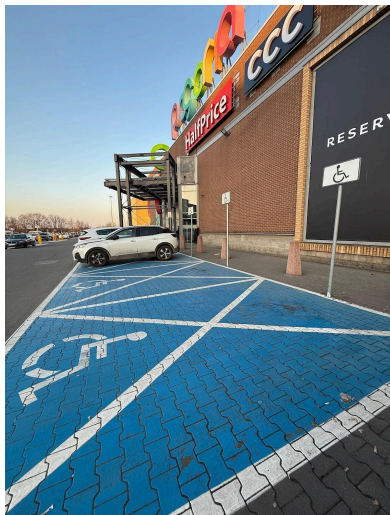
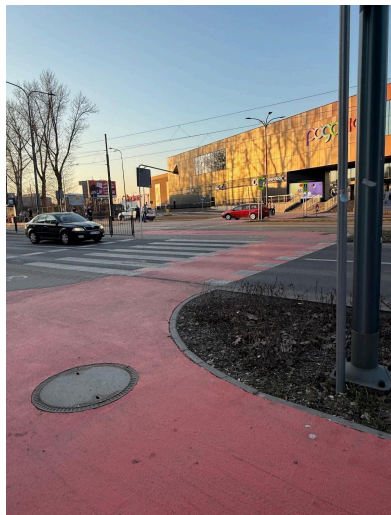
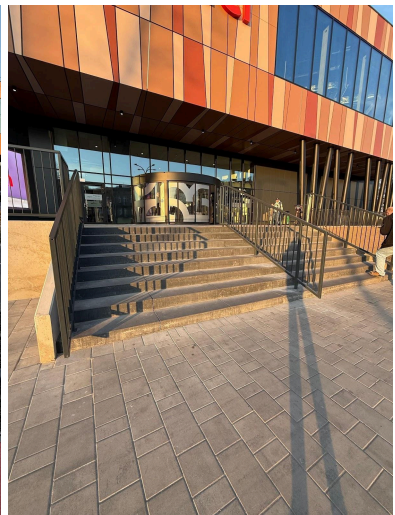
### 4.2.3 Pogoria Shopping Center

Category	Key Criteria	Result
Physical Accessibility	Step-free entrance	Yes
Physical Accessibility	Accessible toilets	Yes
Mobility & Surface	Interior circulation space	Yes
Mobility & Surface	Floor condition	Yes
Visual Accessibility	Tactile guidance	Partial
Visual Accessibility	Accessibility signage	Yes

- Step-free entrance
- Elevators connecting floors
- Wide internal corridors

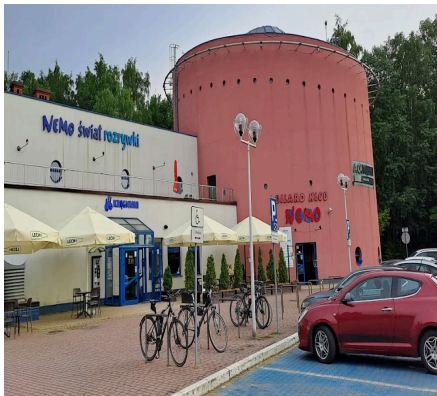
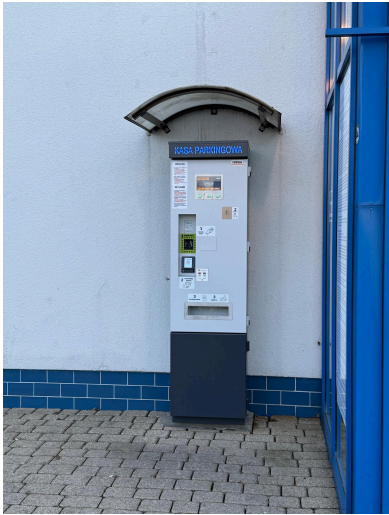
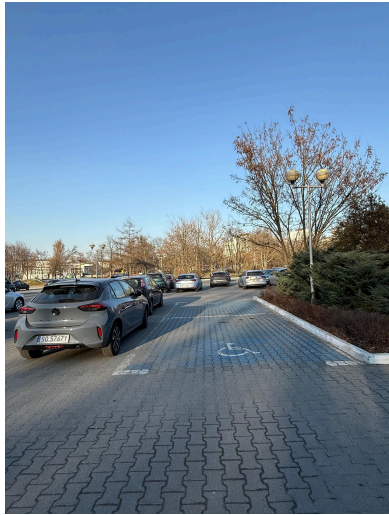
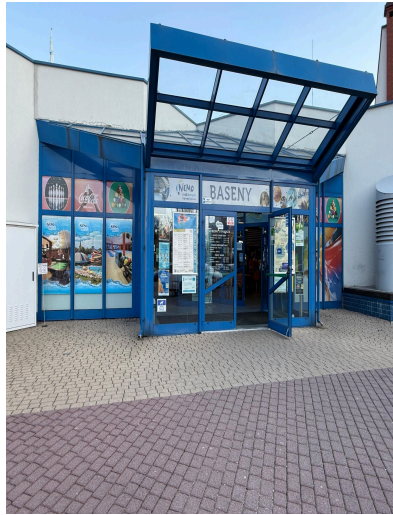
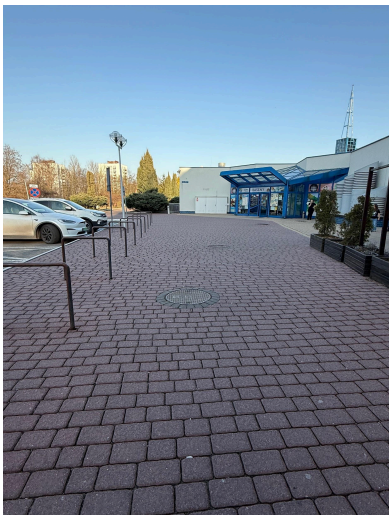
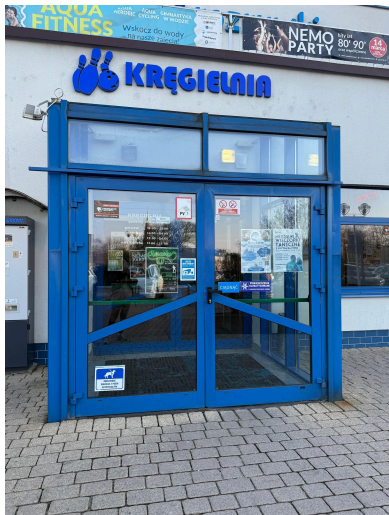
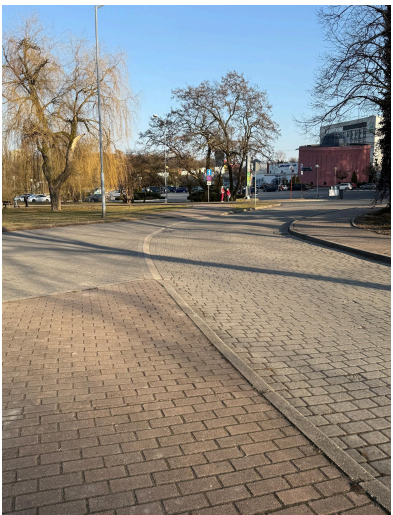
#### 4.2.4 Nemo Aqua Park

Category	Key Criteria	Result
Physical Accessibility	Accessible toilets	Yes
Mobility & Surface	Circulation space	Yes
Visual Accessibility	Tactile guidance	Partial
Visual Accessibility	Accessibility signage	Yes
Visual Accessibility	The orientation is intuitive and clear.	Yes

- Help is clearly offered or indicated
- Spacious circulation areas

- Limited tactile guidance elements

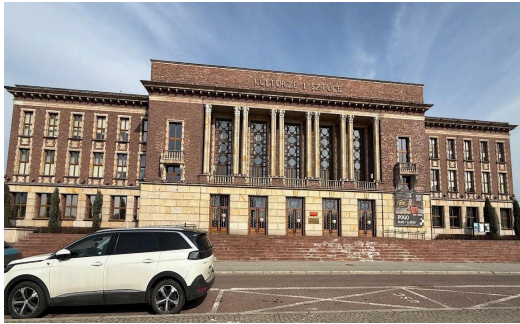
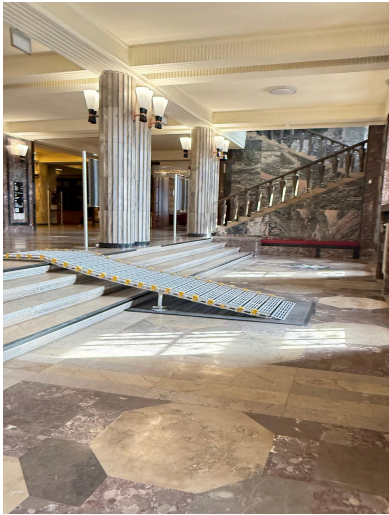
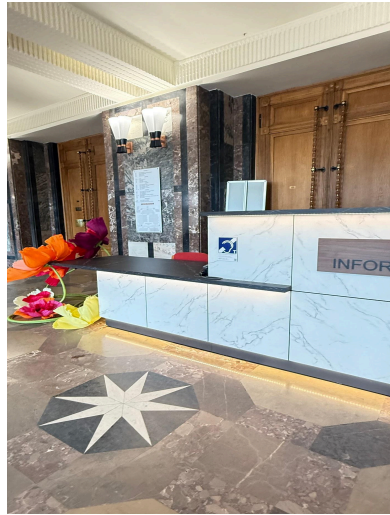
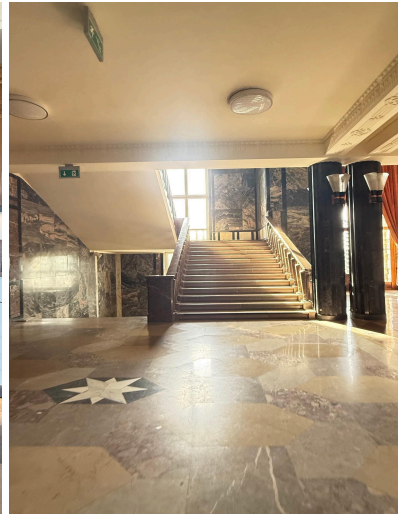
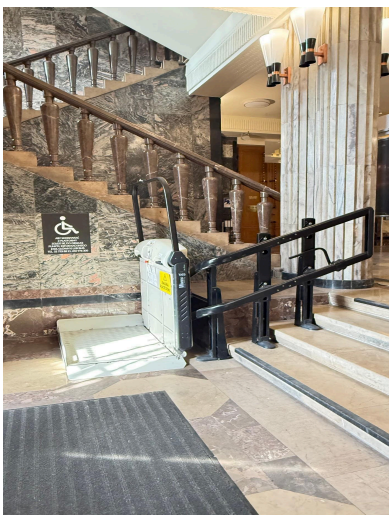
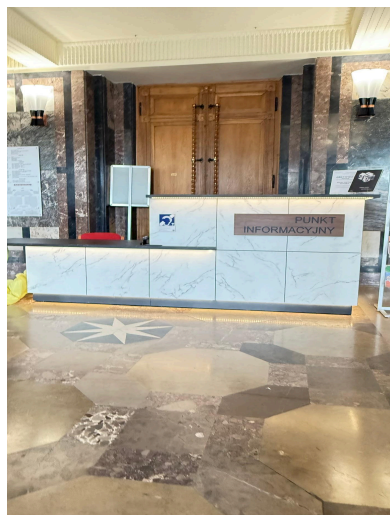
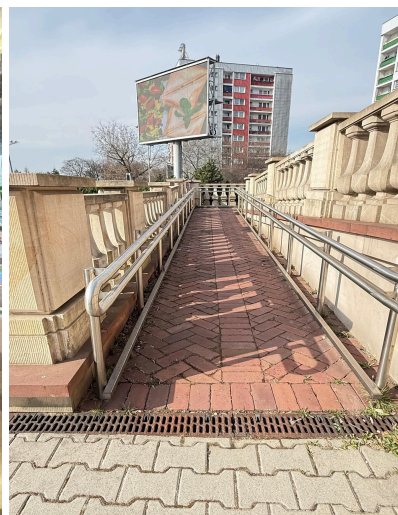
#### 4.2.5 PKZ – Palace of Culture

Category	Key Criteria	Result
Physical Accessibility	Step-free entrance	Yes
Physical Accessibility	Ramp access	Yes
Physical Accessibility	Accessible toilet	Yes
Mobility & Surface	Circulation space	Yes
Visual Accessibility	Clear accessibility signage	Yes

- Step-free entrance
- Spacious circulation areas

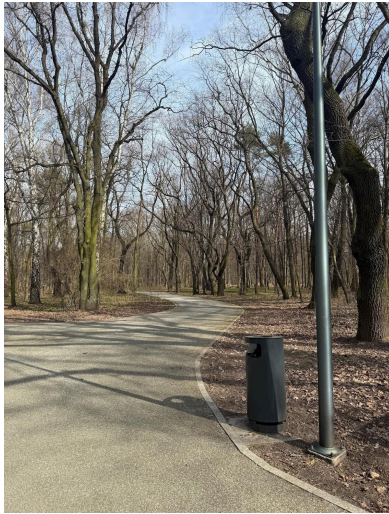
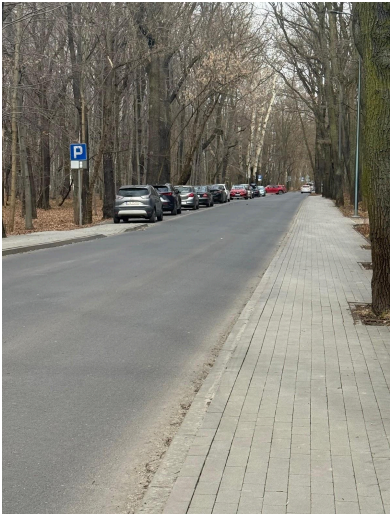
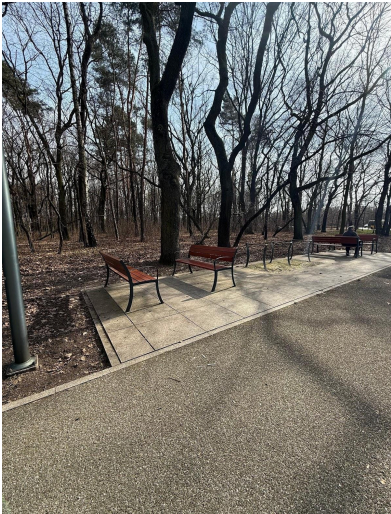
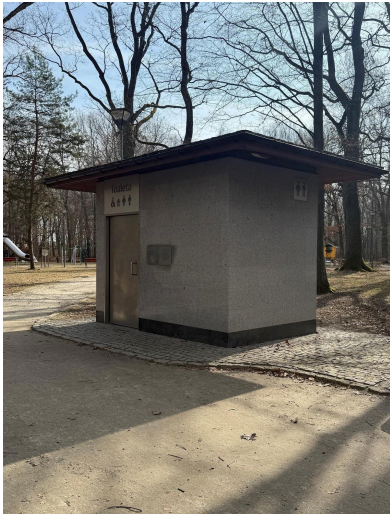
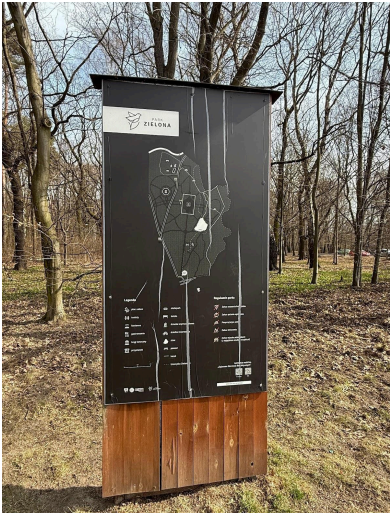
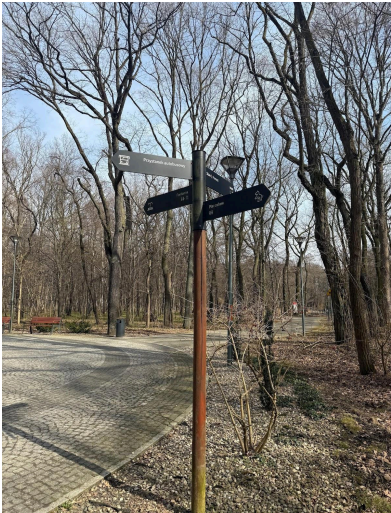
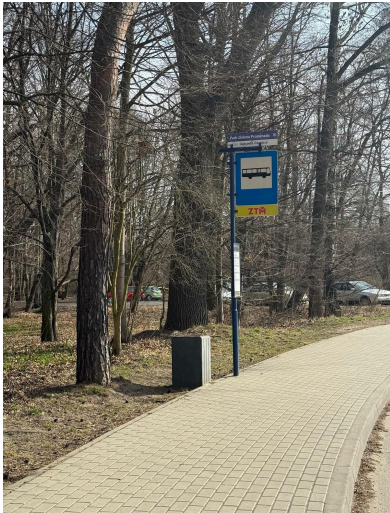
#### 4.2.6 Park Zielona

Category	Key Criteria	Result
Mobility & Surface	Accessible pedestrian paths	Yes
Mobility & Surface	Surface condition	Yes
Mobility & Surface	Maneuvering space	Yes
Visual Accessibility	Accessibility signage	Partial

- Accessible pedestrian paths
- Smooth surfaces on main routes
- Good circulation space

- Some secondary paths partially accessible

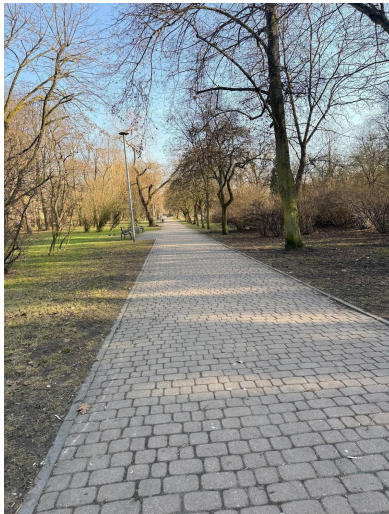
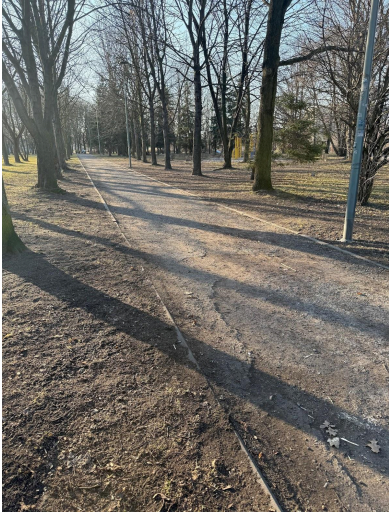
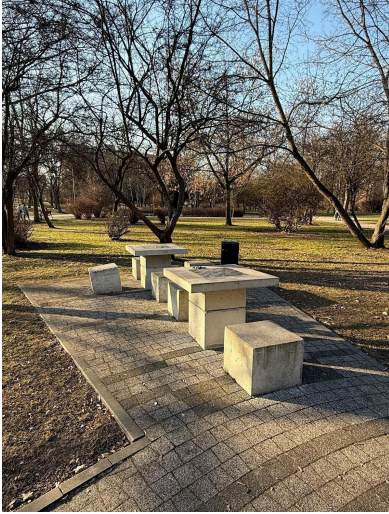
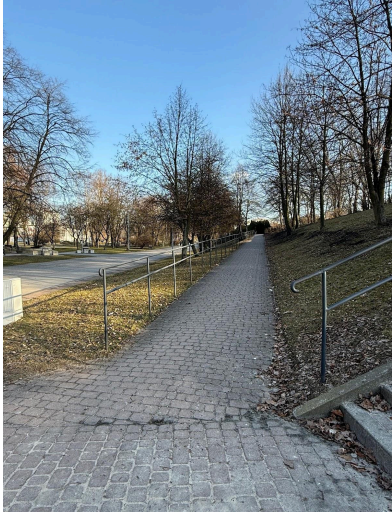
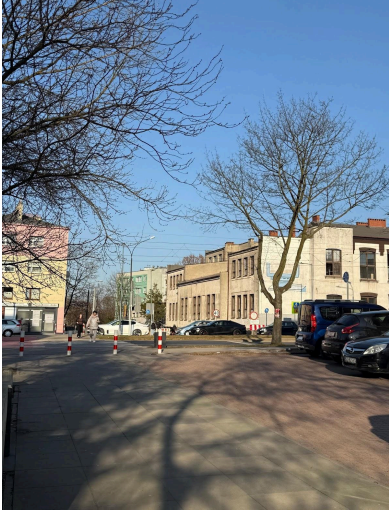
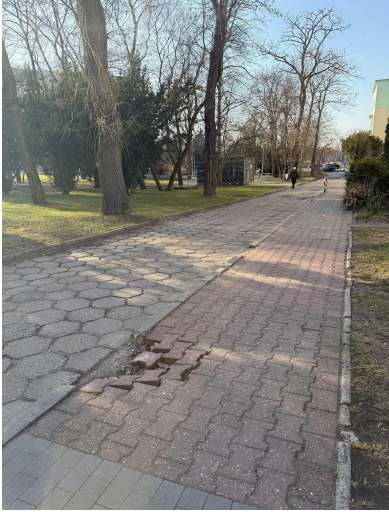
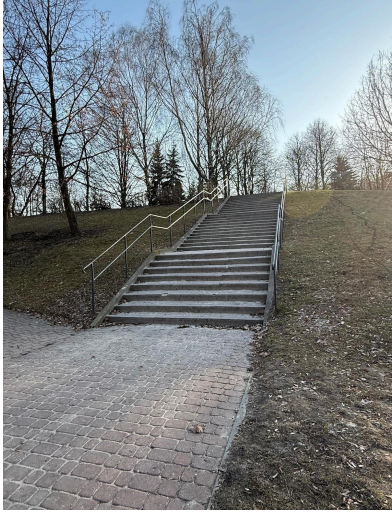
#### 4.2.7 Park Hallera

Category	Key Criteria	Result
Mobility & Surface	Pedestrian paths	Yes
Mobility & Surface	Surface condition	Partial
Mobility & Surface	Circulation space	Yes
Visual Accessibility	Accessibility signage	Partial

- Accessible main pedestrian paths
- Wide circulation areas

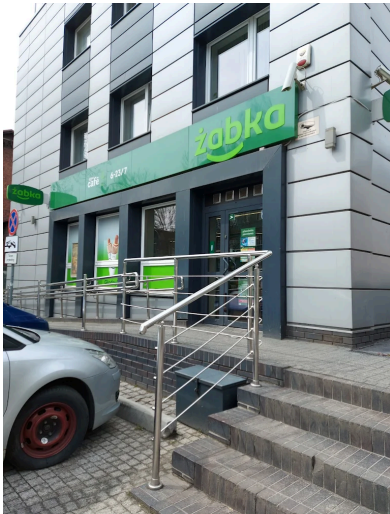
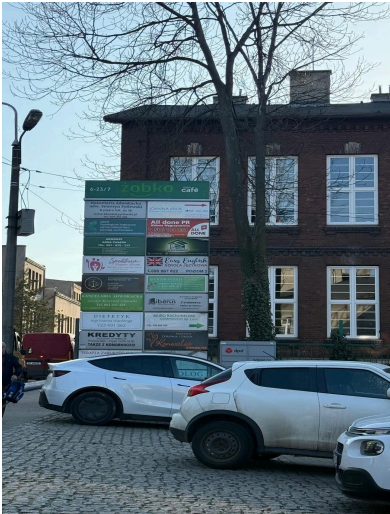
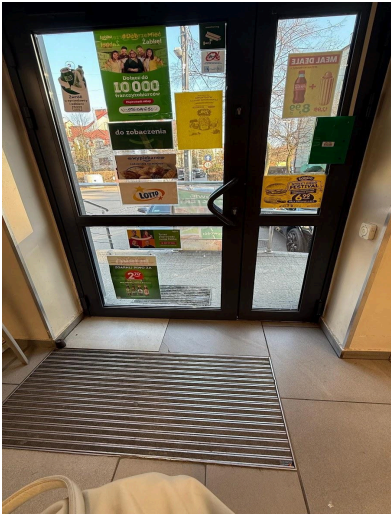
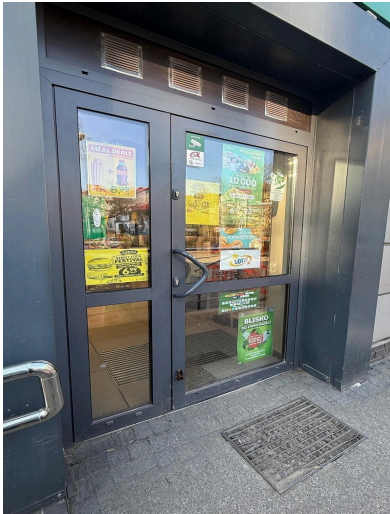
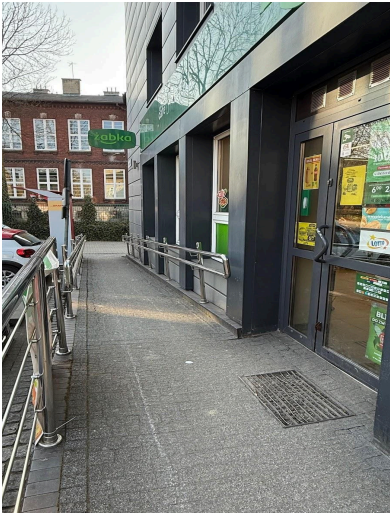
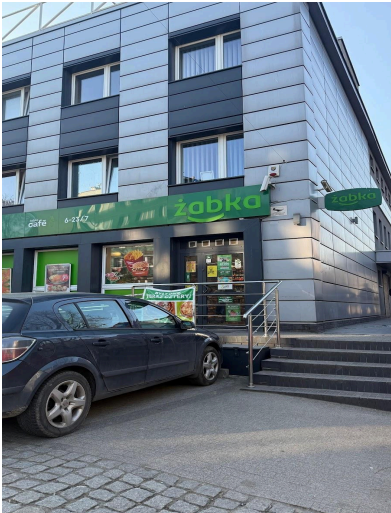
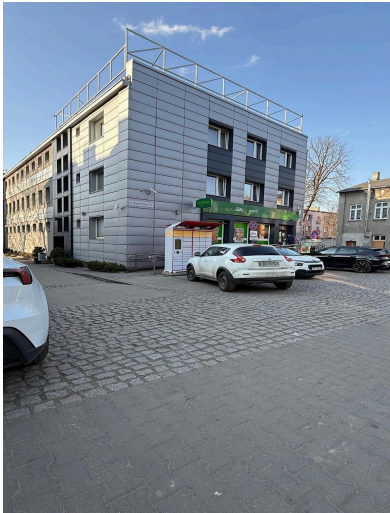
#### 4.2.8 Żabka – Grzegorza Augustynika 7

Category	Key Criteria	Result
Physical Accessibility	Step-free entrance	Yes
Physical Accessibility	Door width	Yes
Service Accessibility	Accessible service counter	Yes
Mobility & Surface	Interior maneuvering space	Yes
Mobility & Surface	Floor stability	Yes

- Step-free entrance
- Adequate door width
- Accessible service counter
- Stable floor surface

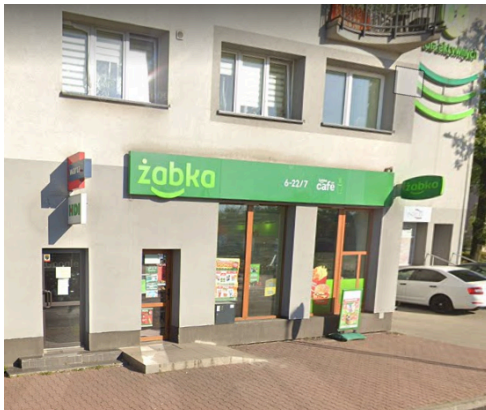
#### 4.2.9 Żabka Górników

Category	Key Criteria	Result
Physical Accessibility	Step-free entrance	Yes
Mobility & Surface	Interior circulation space	Partial
Service Accessibility	Accessible service counter	Yes
Mobility & Surface	Floor stability	Yes
Visual Accessibility	Tactile guidance	Partial

- Step-free entrance
- Accessible interior layout
- Stable floor surface

- Limited accessibility infrastructure in internal corridors

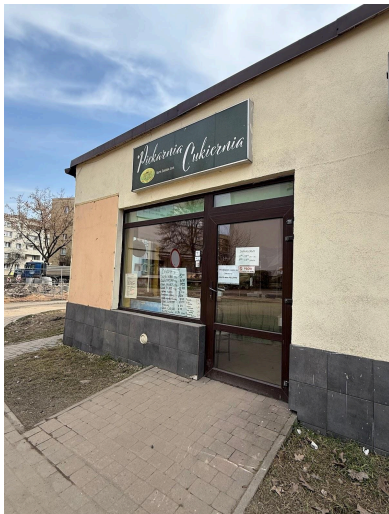
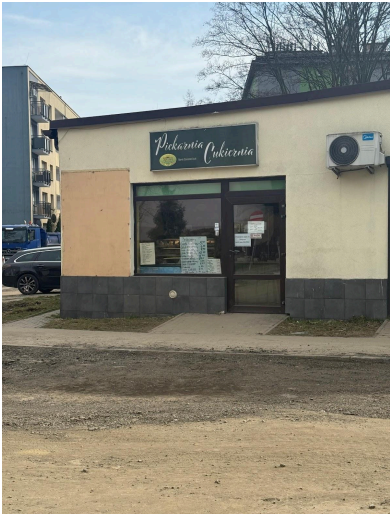
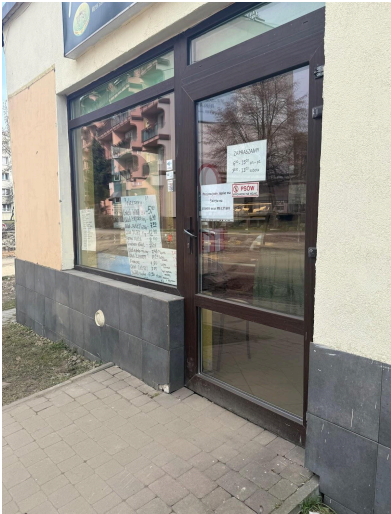
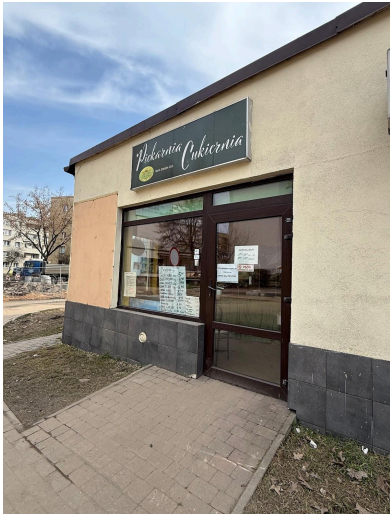
#### 4.2.10 Piekarnia, Cukiernia Łysa Góra

Category	Key Criteria	Result
Physical Accessibility	Step-free entrance	Yes
Mobility & Surface	Interior maneuvering space	Partial
Service Accessibility	Counter accessibility	Yes
Mobility & Surface	Floor condition	Partial

- Basic entrance accessibility
